# Intel<sup>®</sup> Itanium<sup>®</sup> 2 Processor

## Specification Update

Document Number: 251141-014

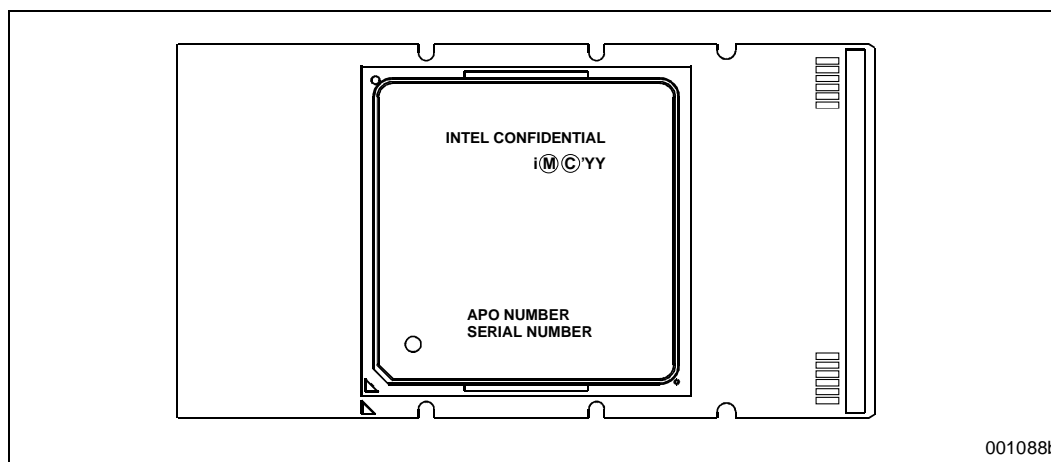
Figure 1-1 shows an example of the laser marking on the IHS. The processor top-side mark provides the following information:

- INTEL Brand/ INTEL Product
- Legal Mark
- Assembly Process Order (APO) Number
- Serial Number

Figure 1-1. Processor Top-Side Marking on IHS
